# Manhole Inspection Summary

Manhole # S09YY1015MH

Insp Date: **7/14/06 2:28 PM**

**Location** Address: **5703 BERKELEY AVE**

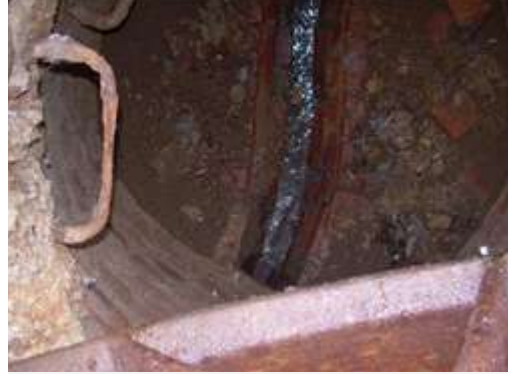
Top View

Corroded steps. Evidence of surcharge - Bench debris.

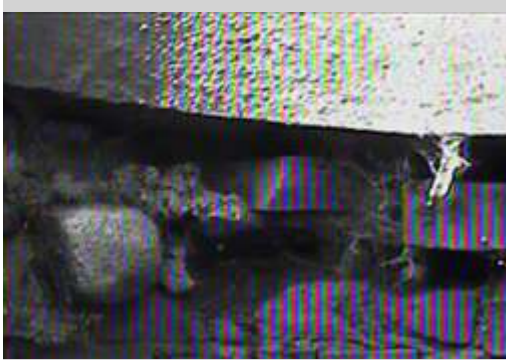
Defect

Frame leaks. Adjustment deterioration, loose brick and infiltration.

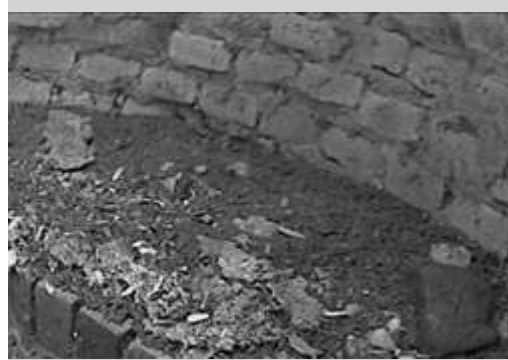
Defect

Bench debris.

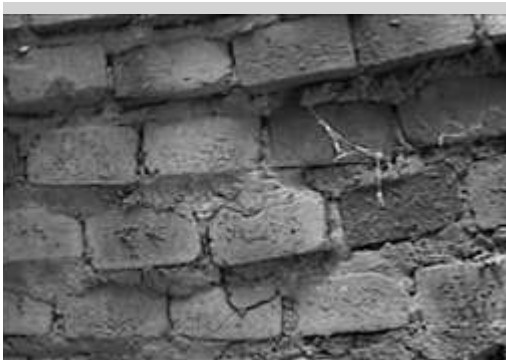
Defect

Corbel deterioration and infiltration.

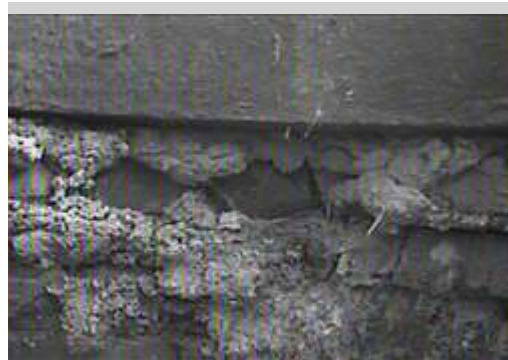
Defect

Frame leaks. Adjustment deterioration and infiltration.

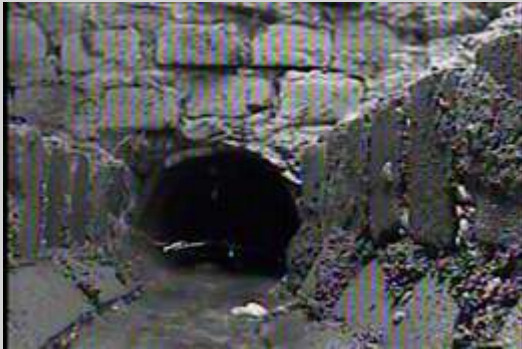
### 8 in. Circular Gravity Sewer Pipe Out @ 12 O'Clock

Barrel deterioration and infiltration. Channel deterioration.

Infiltration: **Evidence** Pipe Seal Cond: **Broken**
